Navajo Abandoned Uranium Mine

Site Screen Report

Mine Name: Monument No. 2
Mine IDs: 241, 521

April 2012

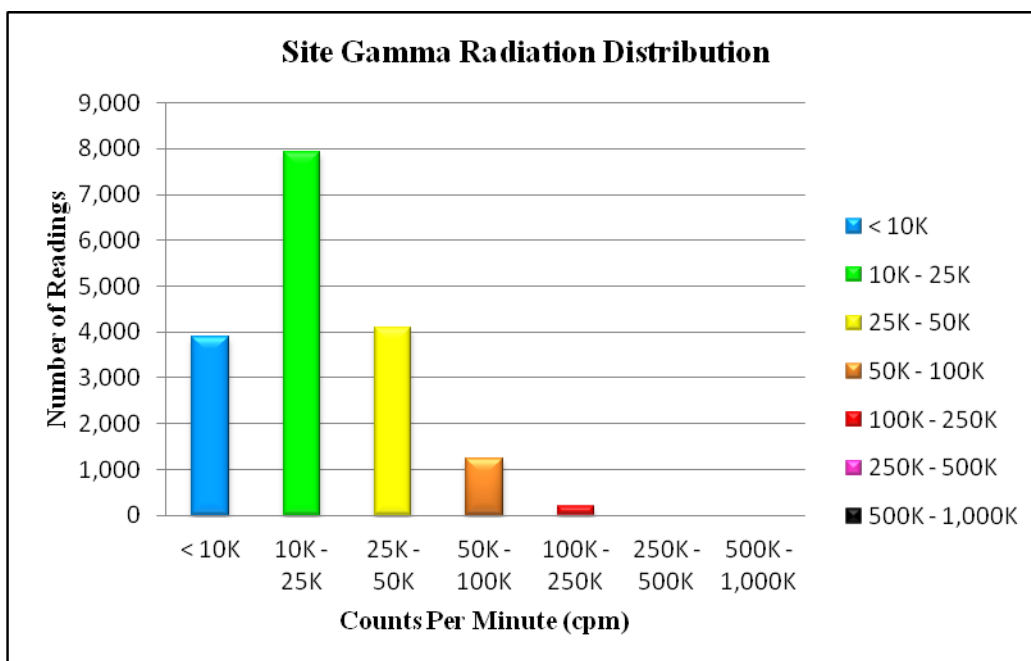
Distribution Chart and Statistics:

A total of 17,777 gamma radiation measurements were collected from the mine site, ranging from 4,158 cpm to 240,322 cpm. Maximum levels of approximately 240,000 cpm were found in the road area. The measurements are represented in Figures 1, 2, 3, 4, 5, and 6.

Site Gamma Radiation Statistics	
Number of Readings	17,777
Minimum (cpm)	4,158
Maximum (cpm)	240,322
Mean (cpm)	23,405
Median (cpm)	17,786
Standard Deviation	20,554

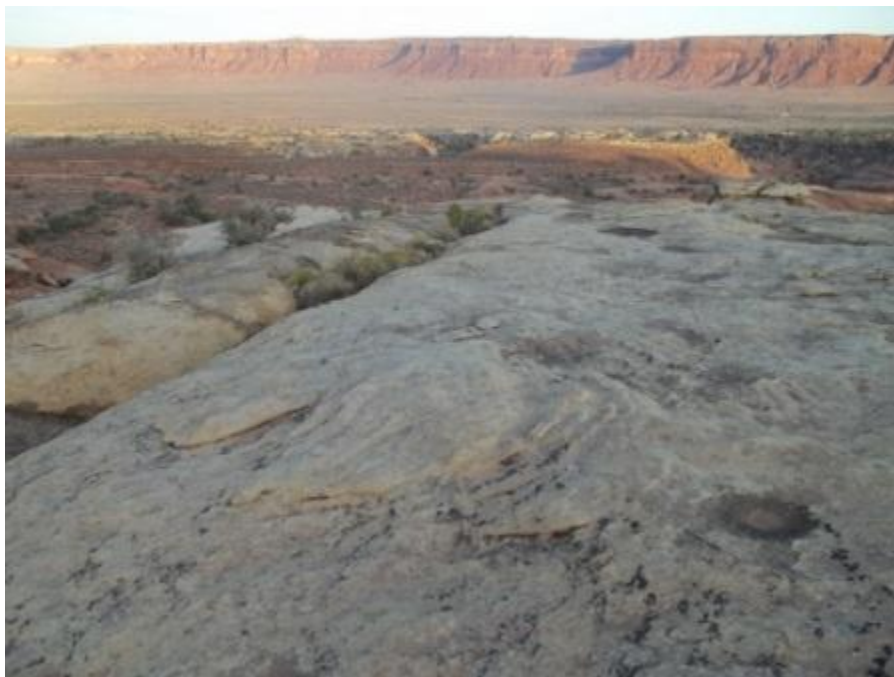
Photo 1

Mine Site #241

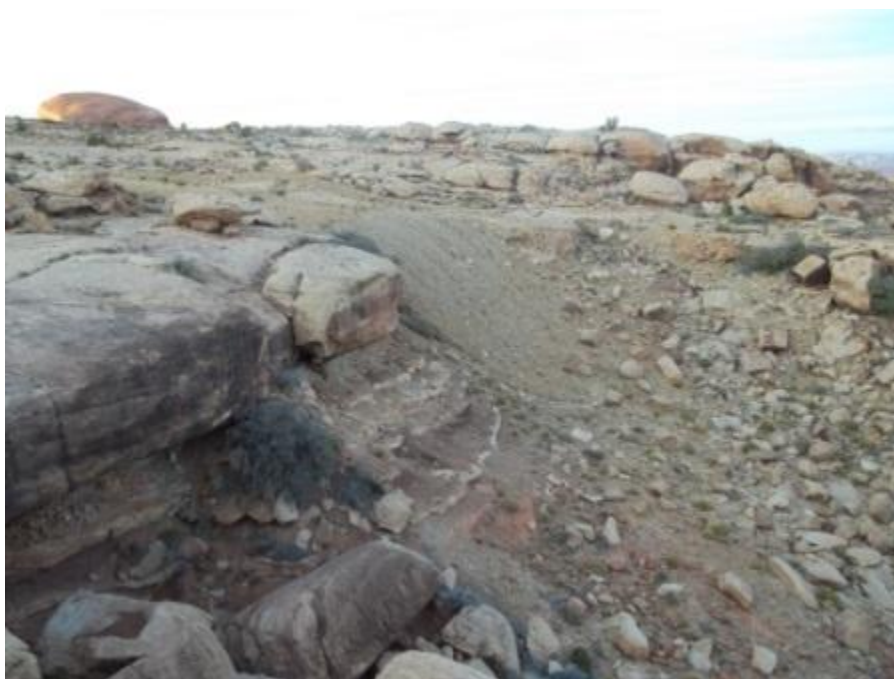
Photo 2

Mine Site #241 – Offsite tailings

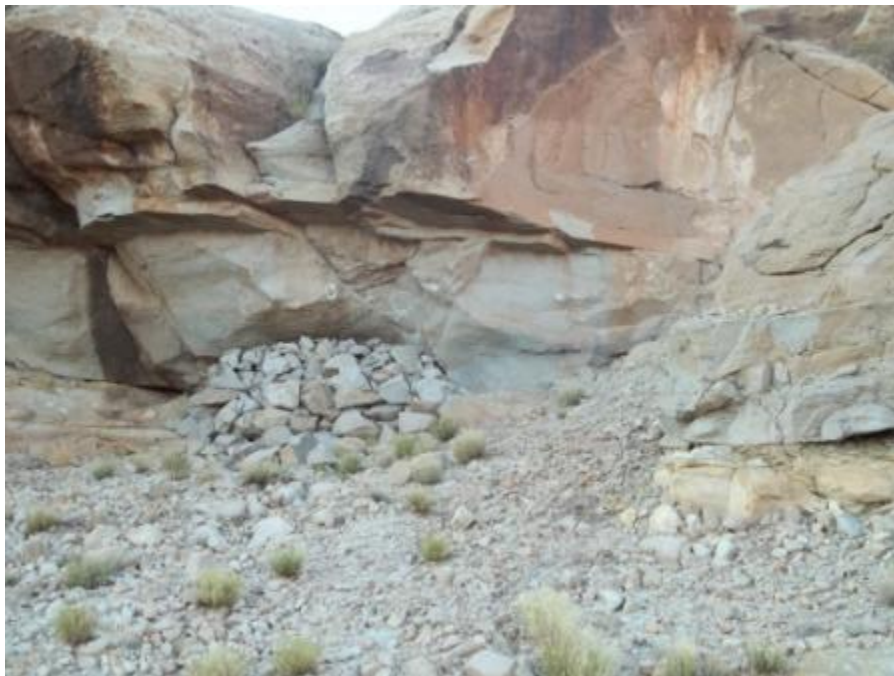
Photo 10

5 adits, all sealed and capped

Mine Site #521 - Adit

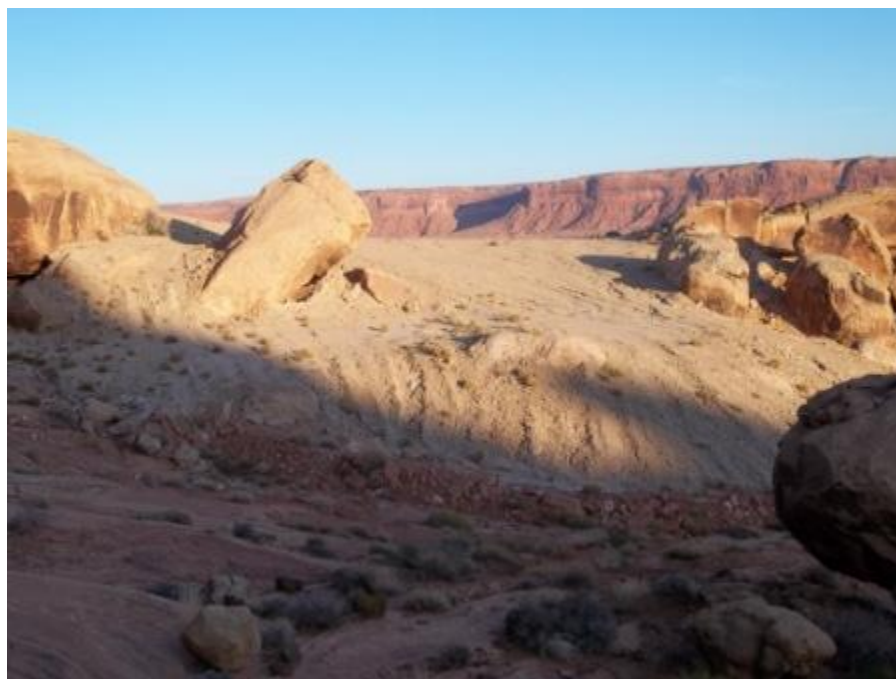
Photo 13

All mine features from topo have been capped including adit and open pits; elevated readings along road; berms have been constructed in at least three locations to limit runoff and overflow; structures have been constructed in the southern wash to capture

Mine Site #521 – Bermed area

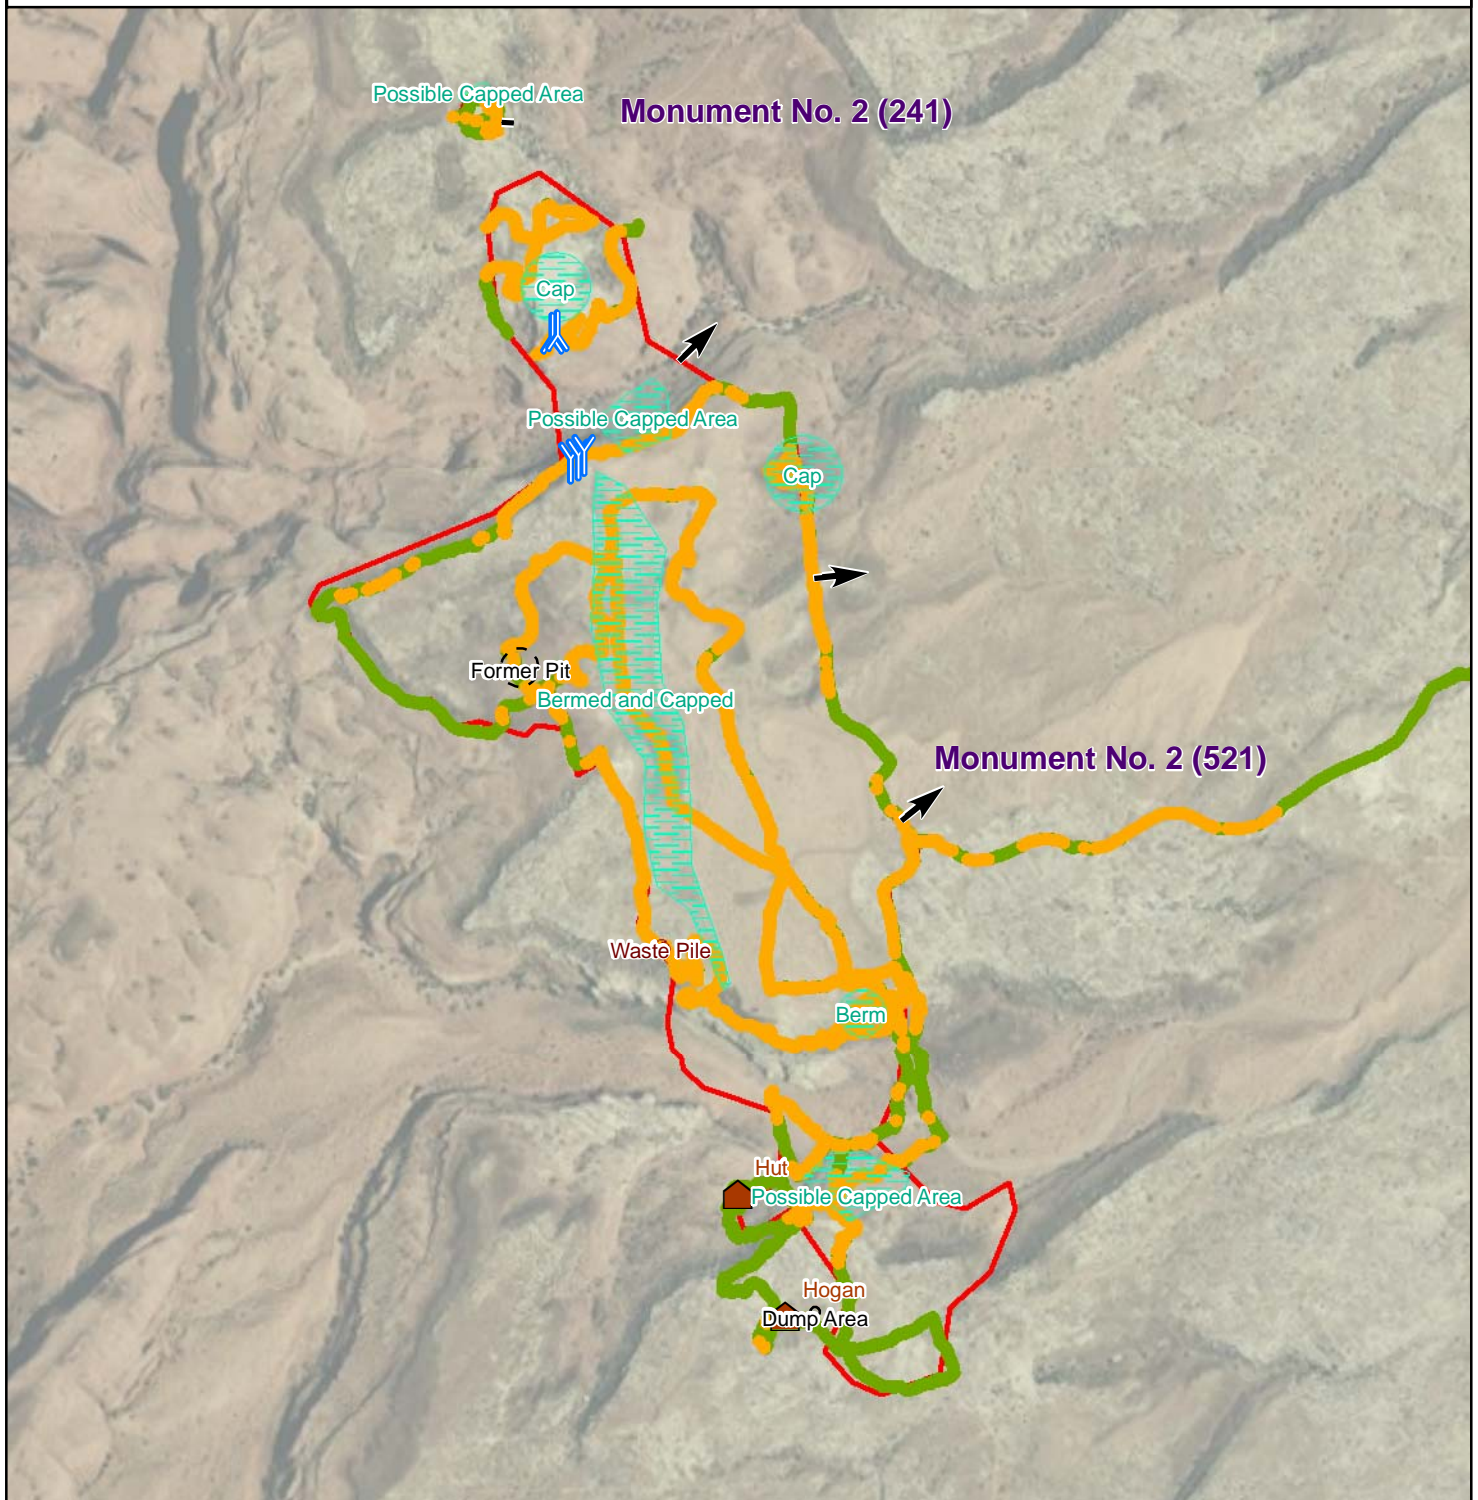
**Figure 1 - Gamma Radiation Measurements, Above Two Times Background
Monument No. 2 (241, 521)
Kayenta Chapter, Navajo Nation**

Average background 7,393 cpm

A total of 357 gamma radiation measurements were collected from the mine site, ranging from 8,055 cpm to 28,307 cpm. The measurements are represented in Figures 1, 2, 3 and 4.

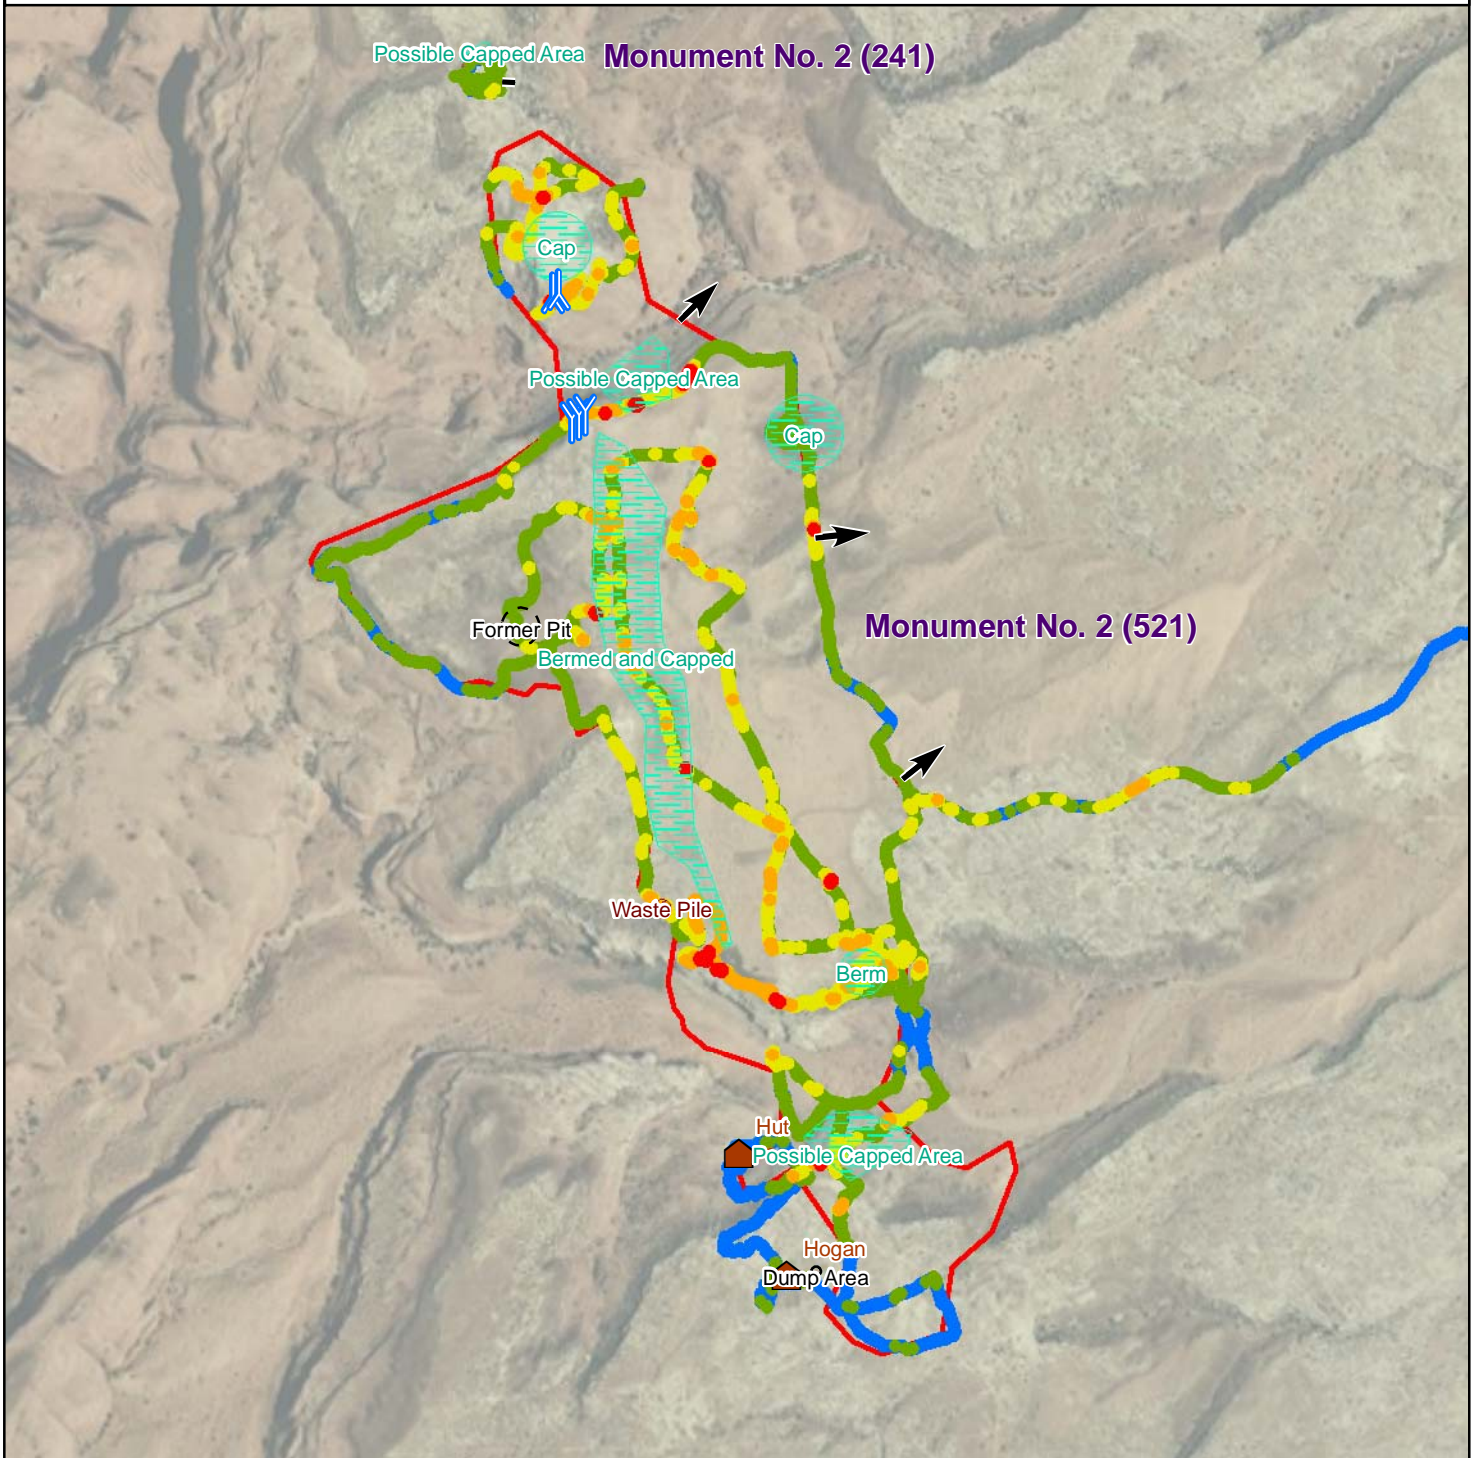
**Figure 2 - Gamma Radiation Measurements
Monument No. 2 (241, 521)
Kayenta Chapter, Navajo Nation**

Average background 7,393 cpm

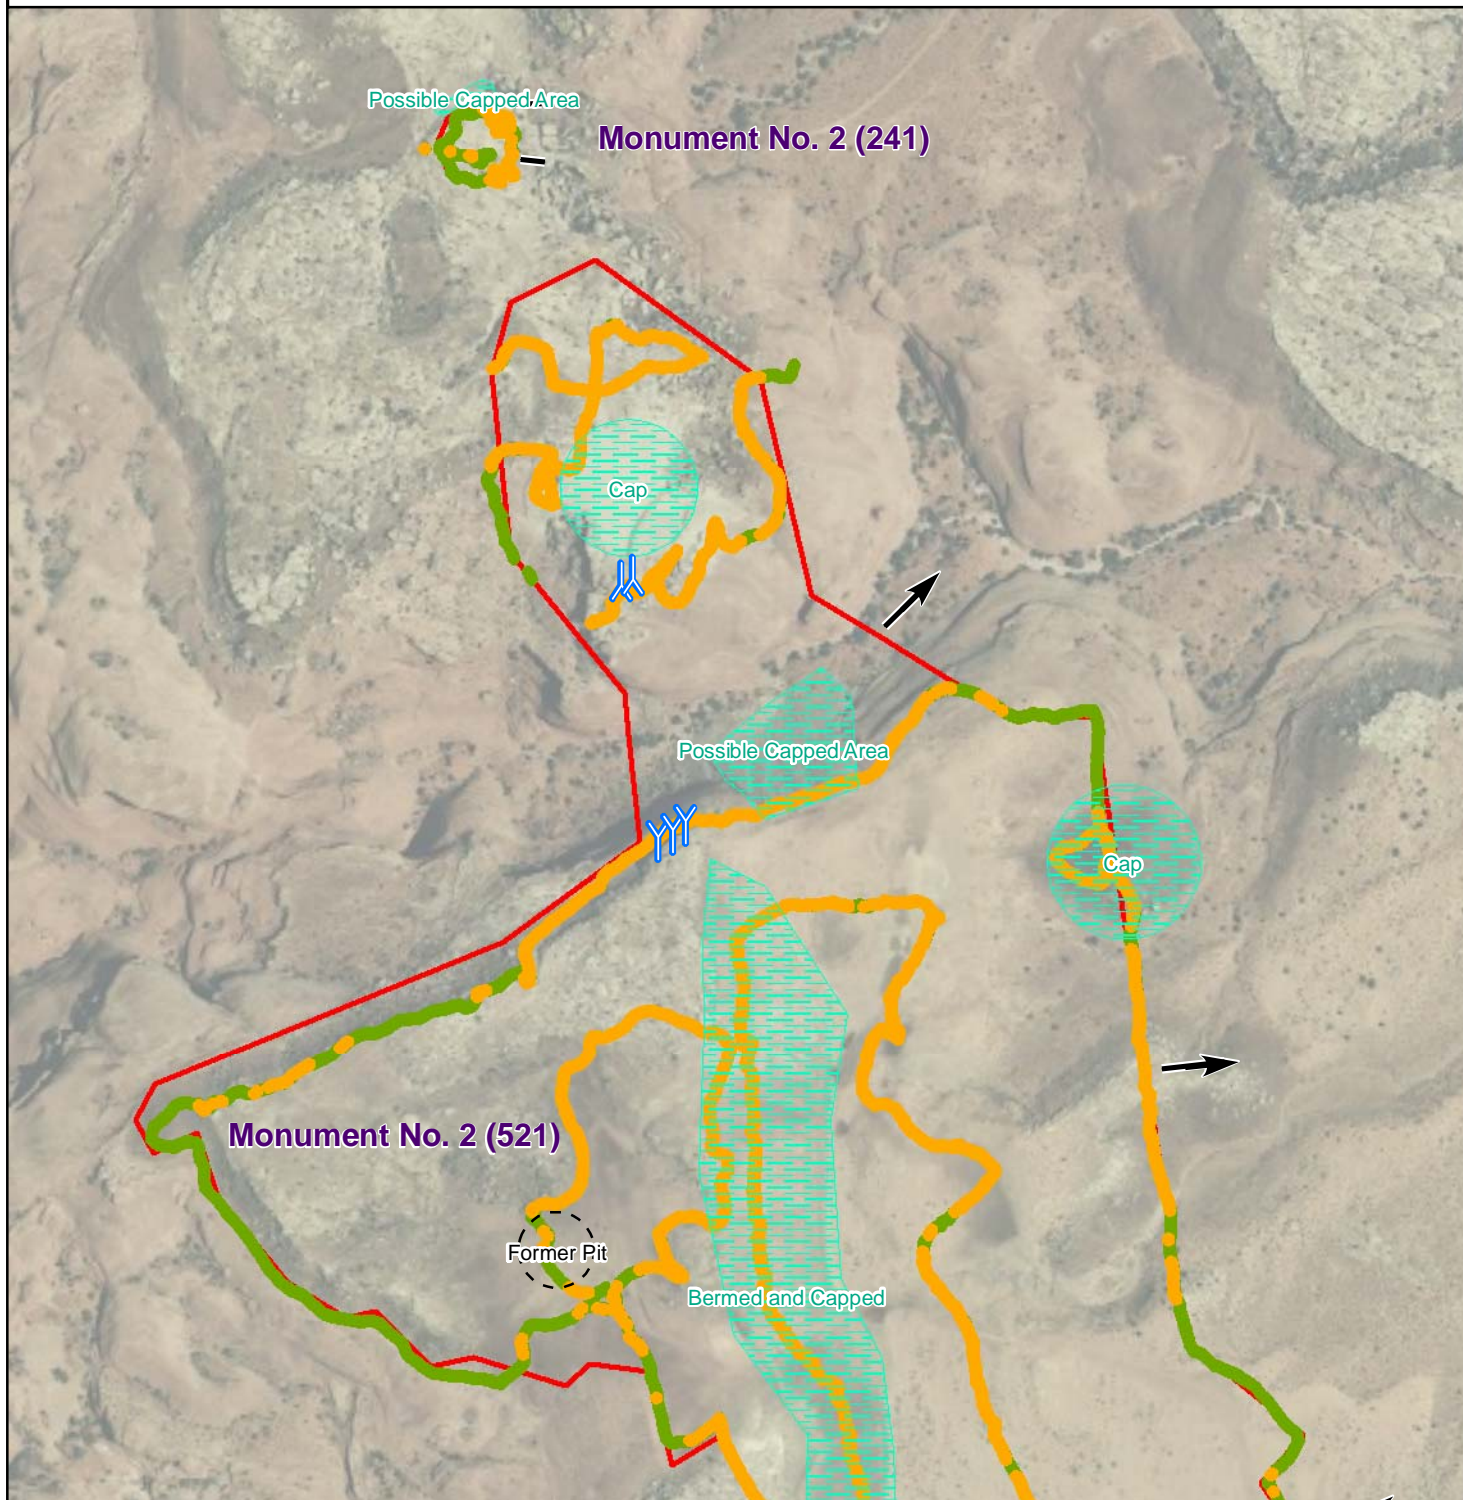
**Figure 3 - Gamma Radiation Measurements, Above Two Times Background
Monument No. 2 (241, 521)
Kayenta Chapter, Navajo Nation**

Average background 7,393 cpm

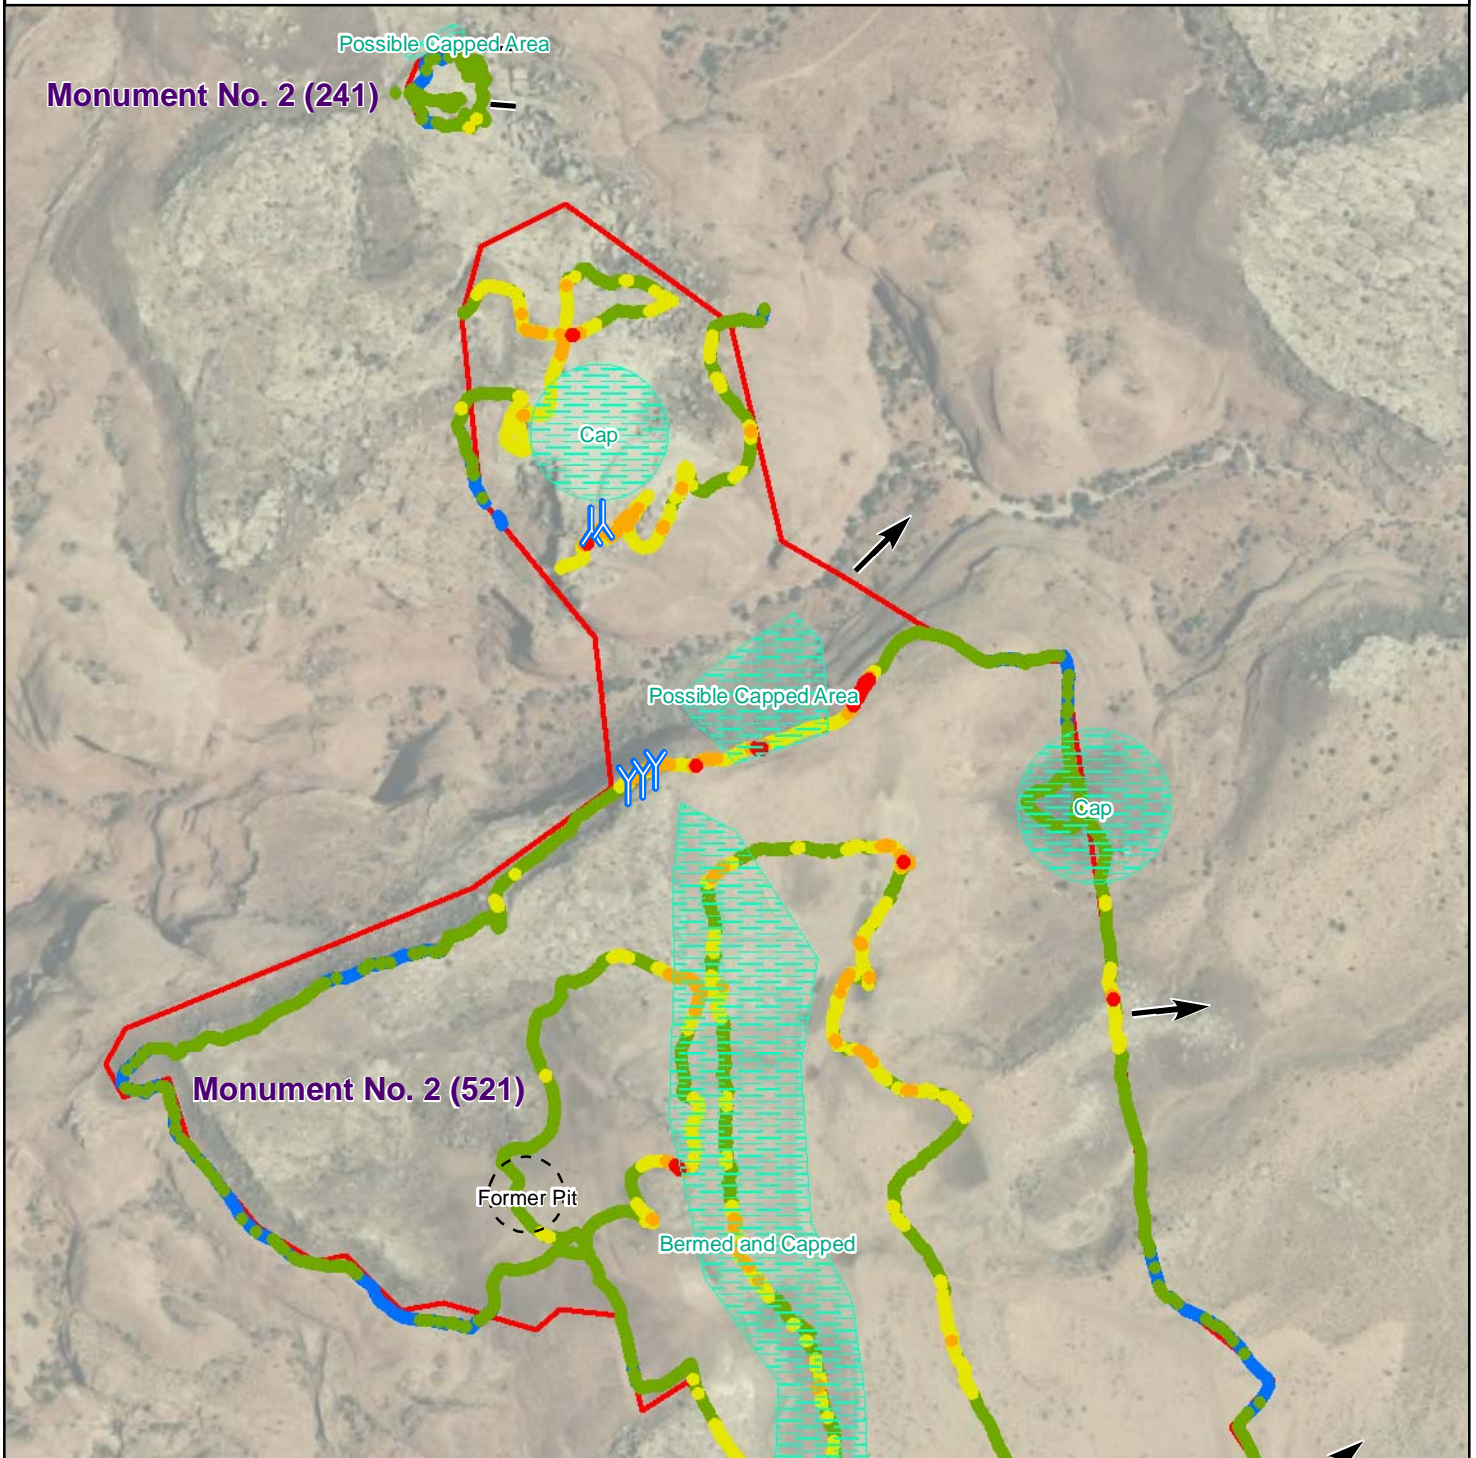
**Figure 4 - Gamma Radiation Measurements
Monument No. 2 (241, 521)
Kayenta Chapter, Navajo Nation**

Average background 7,393 cpm

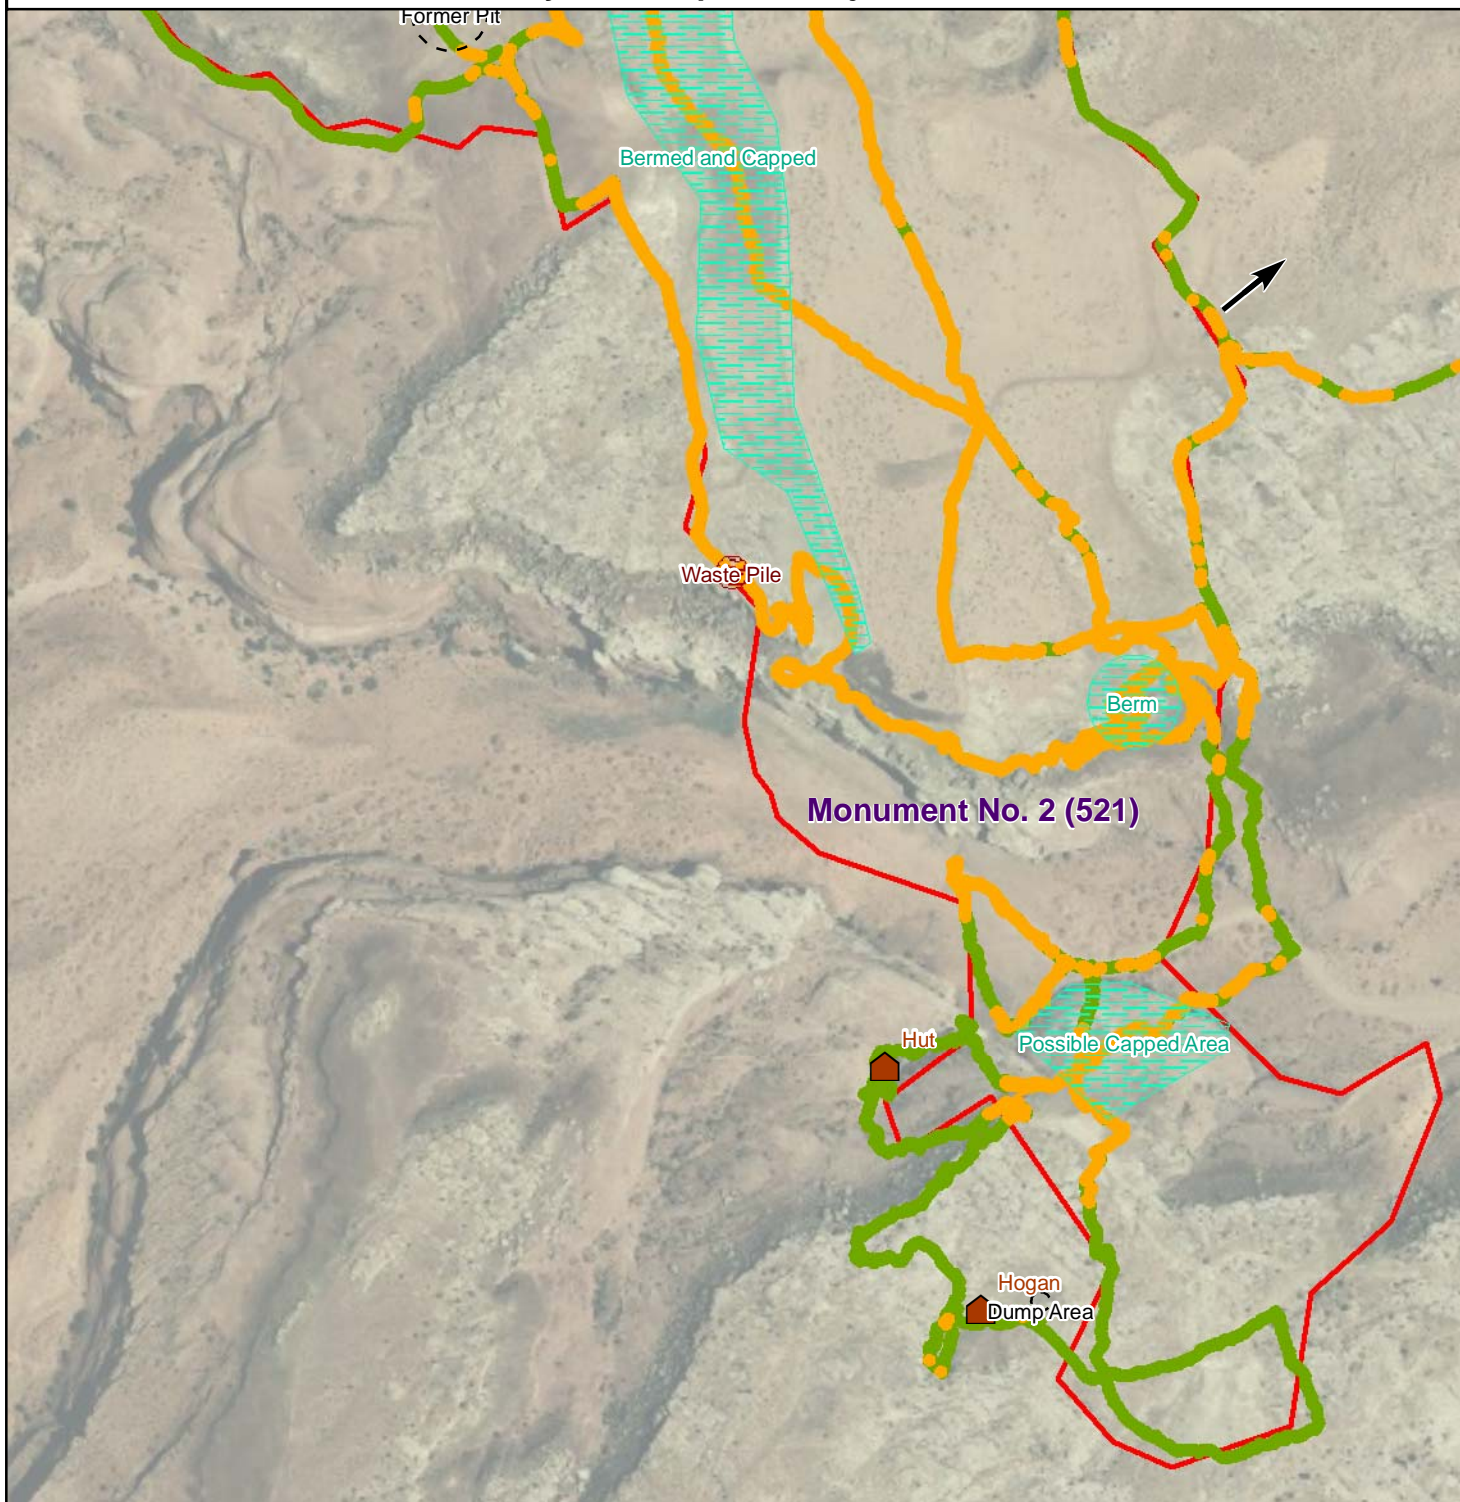
**Figure 5 - Gamma Radiation Measurements, Above Two Times Background
Monument No. 2 (241, 521)
Kayenta Chapter, Navajo Nation**

Average background 7,393 cpm

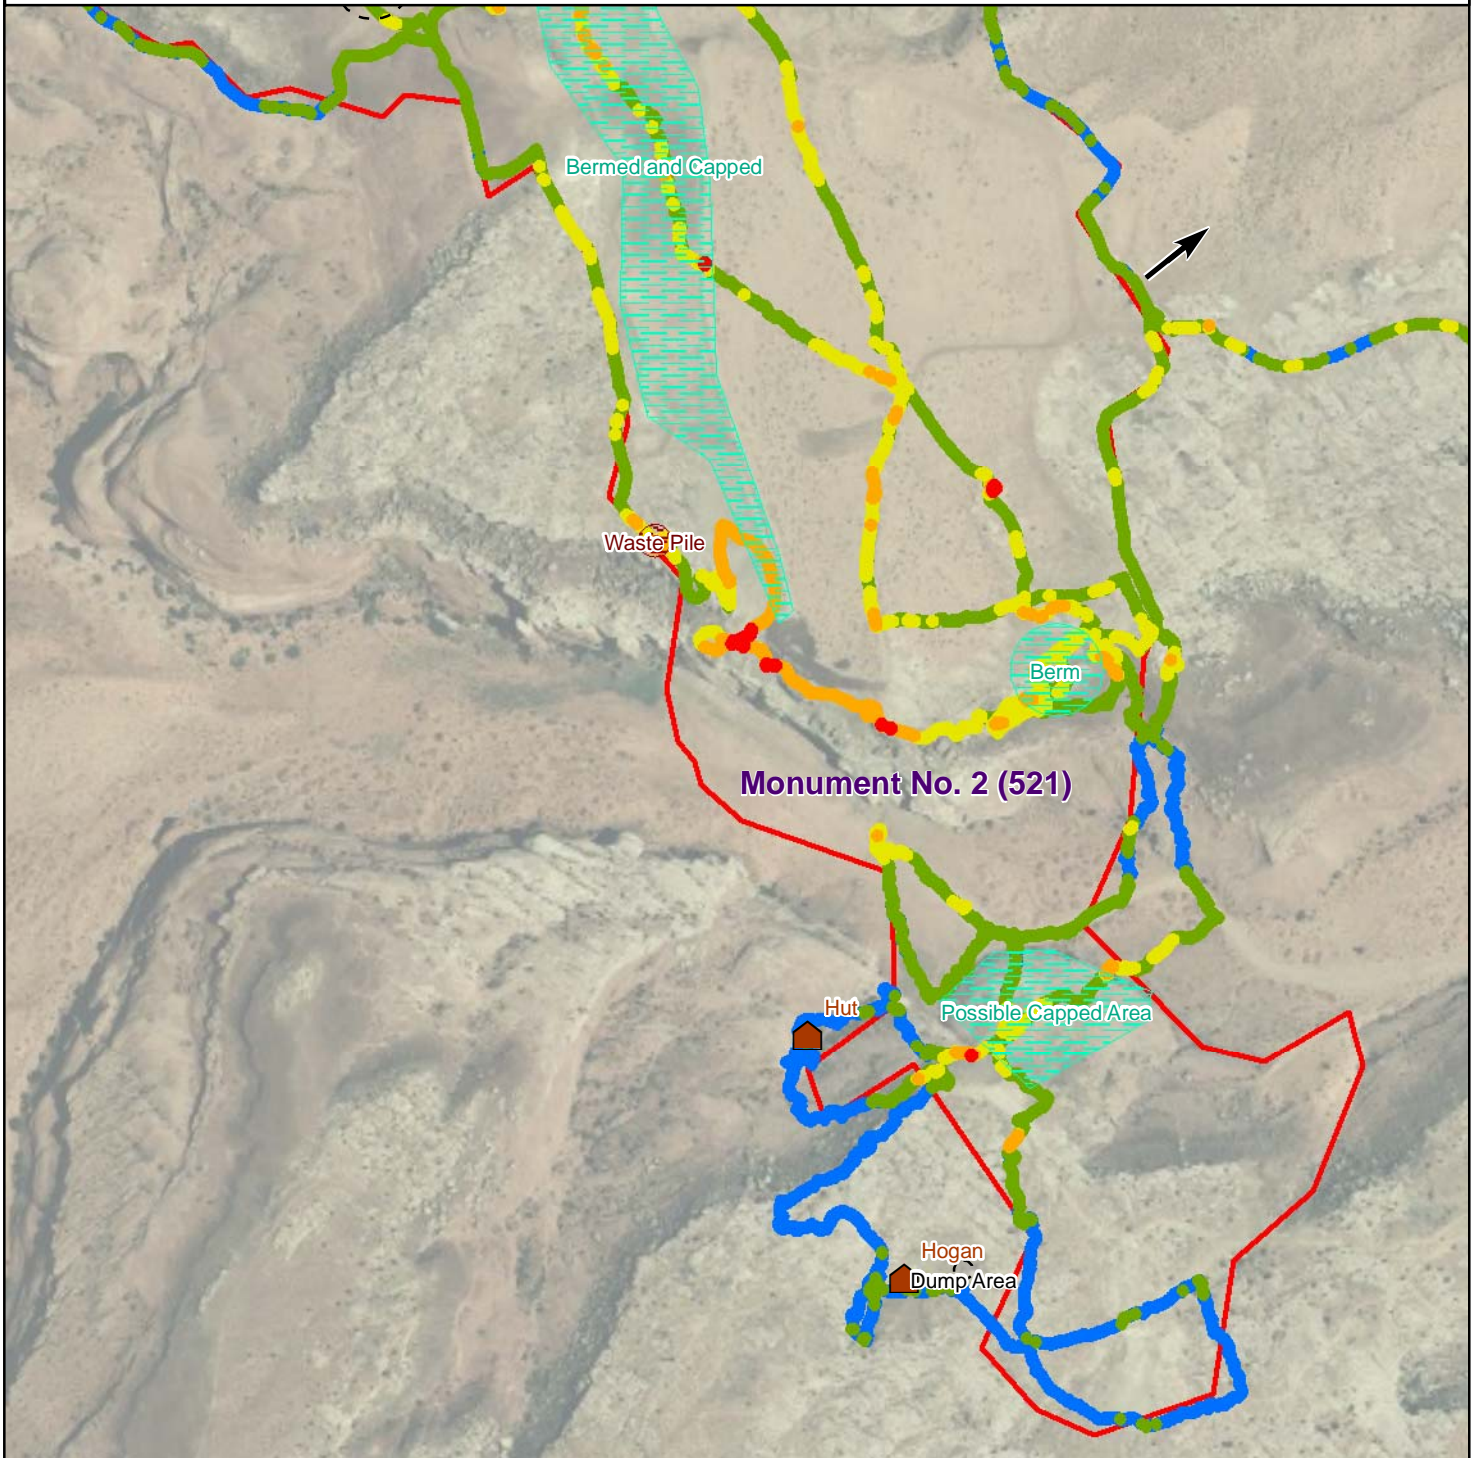
**Figure 6 - Gamma Radiation Measurements
Monument No. 2 (241, 521)
Kayenta Chapter, Navajo Nation**

Average background 7,393 cpm
